# Home Inspection Report

## 123 Example Ln

Inspected By: Kris Beall

Prepared For: Demo Dan  
Inspected On Sat, Apr 16, 2022 at 8:00 AM

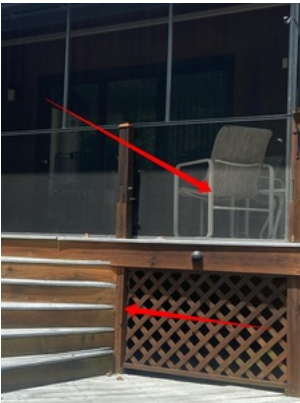
Guardrail missing on step wonders and upper deck. Install appropriate protection to prevent falls.

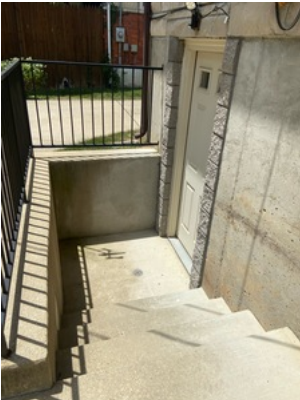
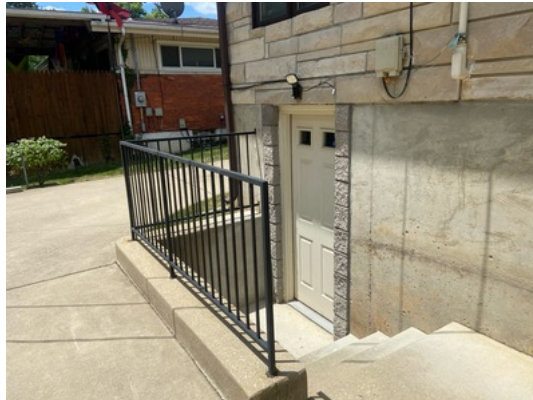
Handrail missing at basement exterior entry. Install for safety.

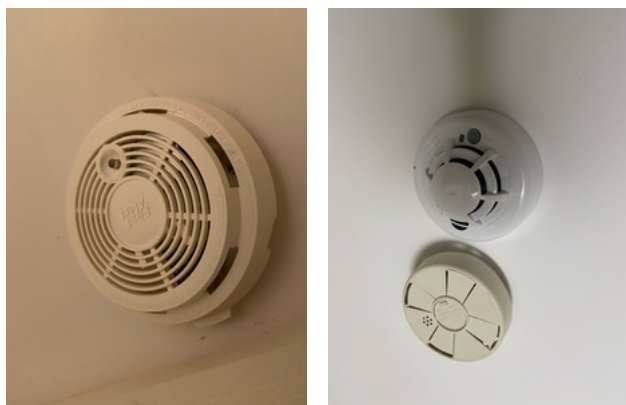
Smoke detectors are 9 volt type. Replace with 10 year lithium type or hard wired smoke detectors on each occupied level.

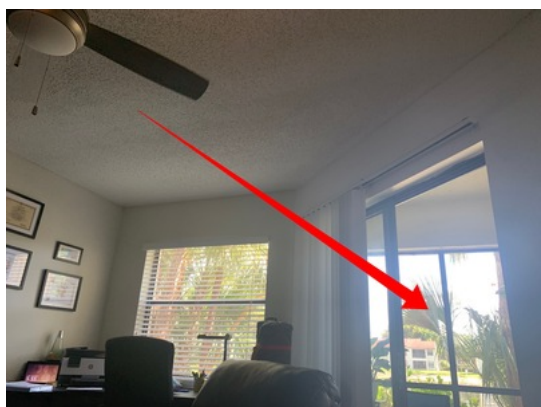
There is rotten wood on the lower left of the door. We recommend the rotten wood be replaced by a qualified repair technician.

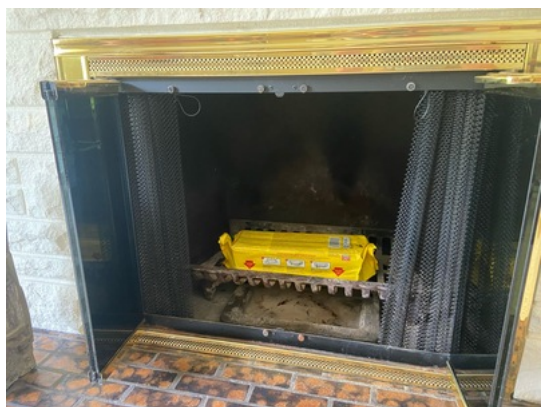
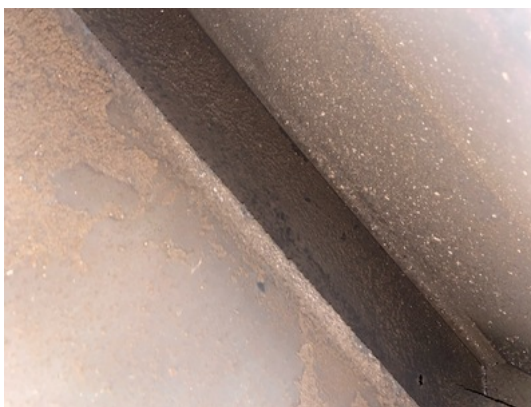
Fireplace flue appears very dirty. Have cleaned by chimney sweep before use for safety.

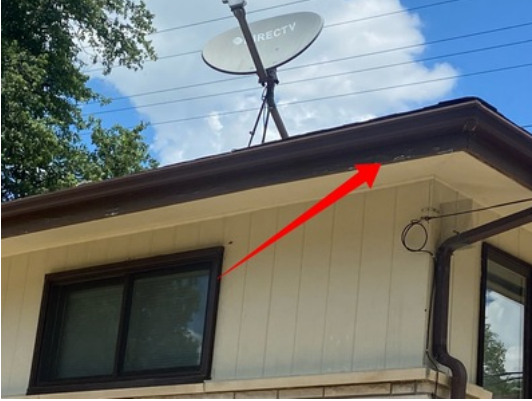
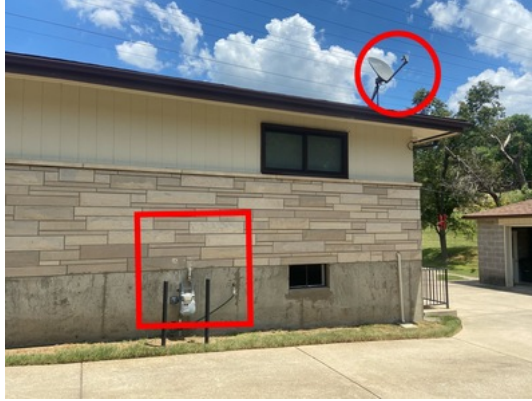
Exterior wood trim has peeling paint and possible minor wood damage. Repair, prep and paint to prevent wood from rotting.

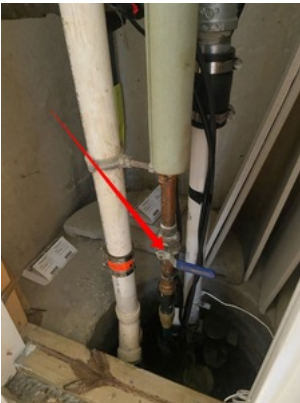
Water driven backup sump pump at rear right sump is not functioning. Repair or replace by licensed plumber.

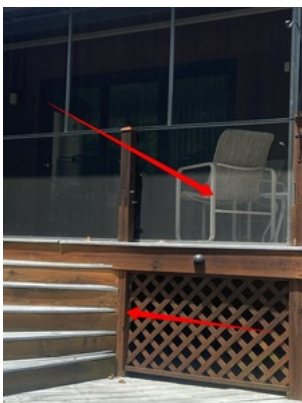
#### Comment 1

Guardrail missing on step wonders and upper deck. Install appropriate protection to prevent falls.

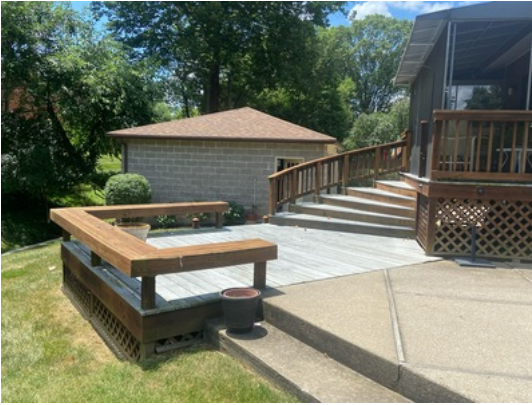
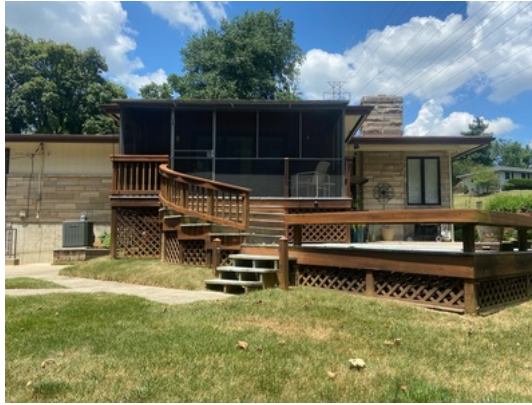
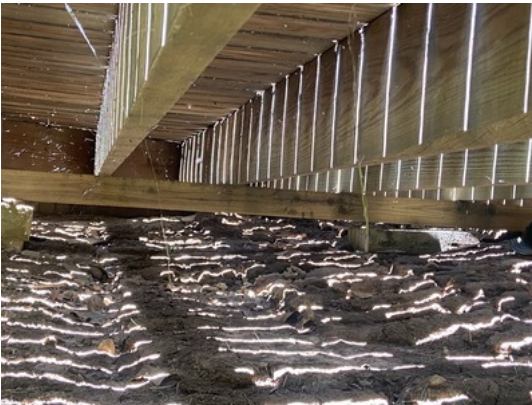
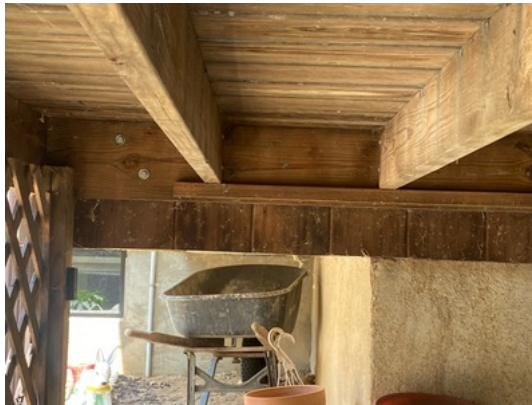
#### Comment 2

Deck has been well maintained and is acceptable condition.

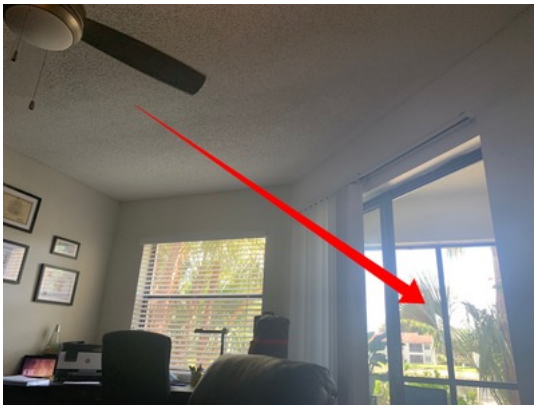
#### Comment 3

There is rotten wood on the lower left of the door. We recommend the rotten wood be replaced by a qualified repair technician.

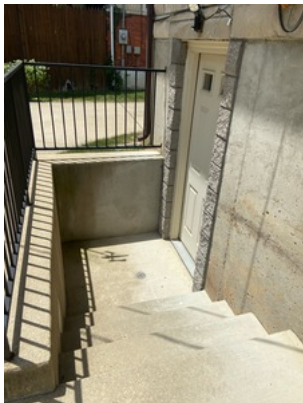
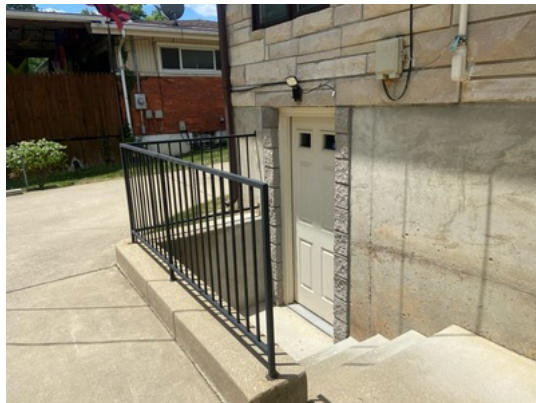
Handrail missing at basement exterior entry. Install for safety.

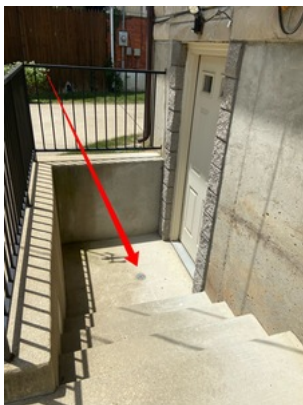
Keep basement entry drain clear of debris or water will come in through door.

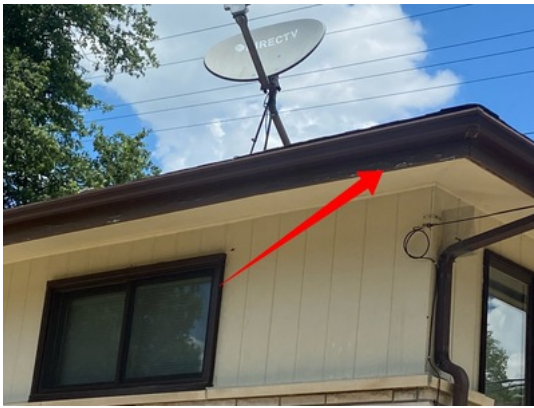
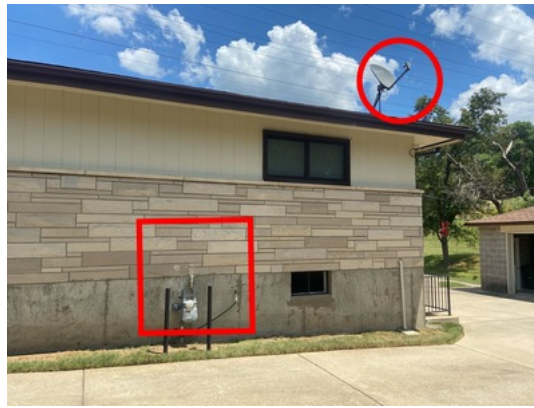
Exterior wood trim has peeling paint and possible minor wood damage. Repair, prep and paint to prevent wood from rotting.

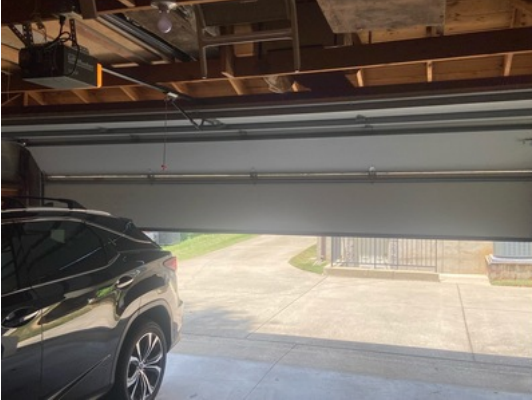
Vehicle door and opener operates as expected.

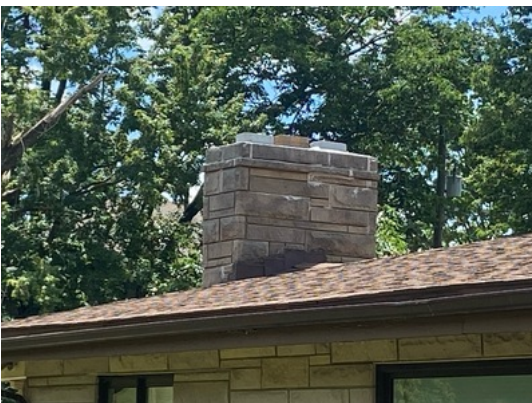
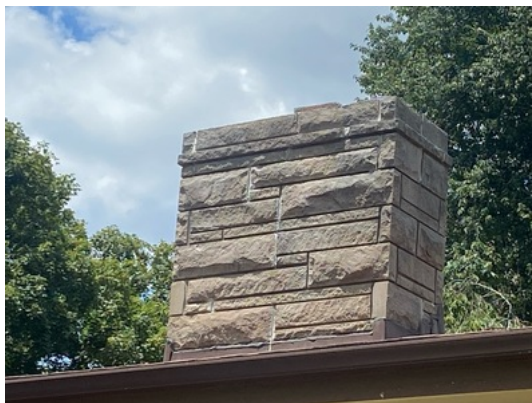
### Comment 8

Prior repairs visible to chimney mortar and bricks. Monitor for signs of future water penetration and address if needed.

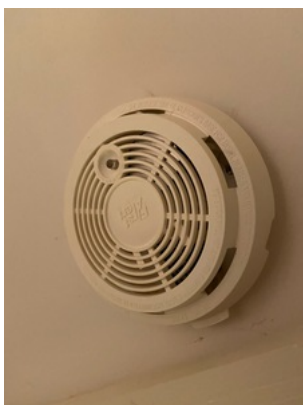
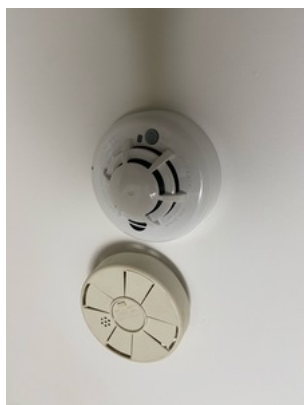
#### Comment 9

Smoke detectors are 9 volt type. Replace with 10 year lithium type or hard wired smoke detectors on each occupied level.

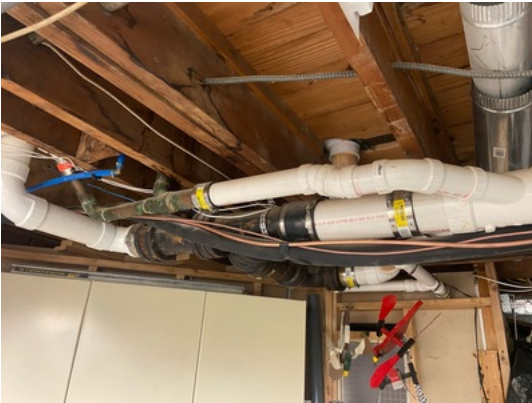
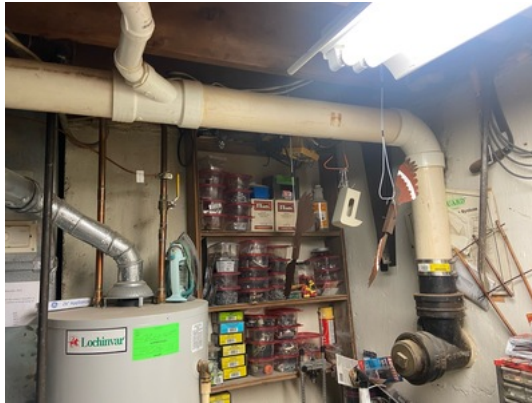
Easter lives have been mostly replaced with pvc. Ok.

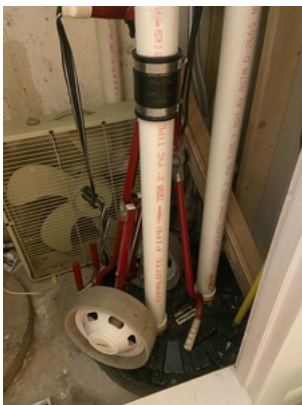
Sewage ejector installed in basement. Do not use basement plumbing when power is out and be careful what is flushed. No wipes or hygiene products.

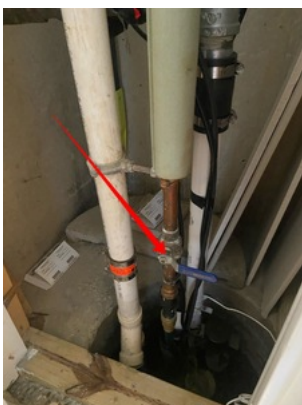
### Comment 13

Water driven backup sump pump at rear right sump is not functioning. Repair or replace by licensed plumber.

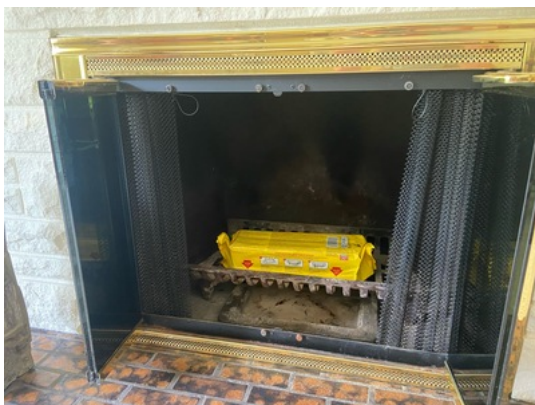
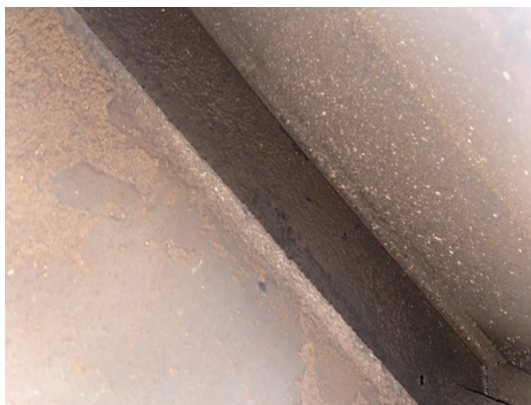
#### Comment 15

Fireplace flue appears very dirty. Have cleaned by chimney sweep before use for safety.

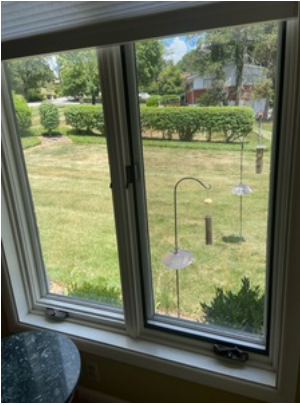
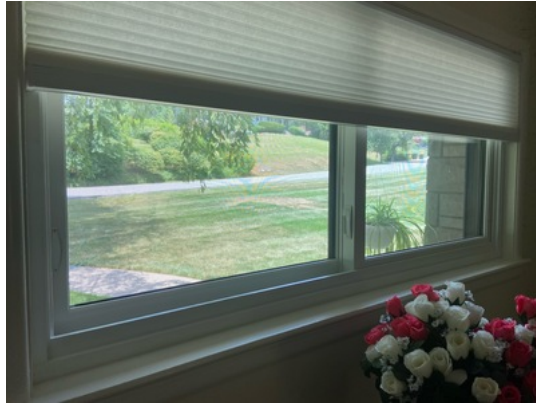
#### Comment 16

Original Windows have been replaced with vinyl thermopane types. Operate as expected. Ok.
