# Home Inspection Report

## 123 Example Ln

Inspected By: Kris Beall

Prepared For: Demo Dan  
Inspected On Sat, Apr 16, 2022 at 8:00 AM

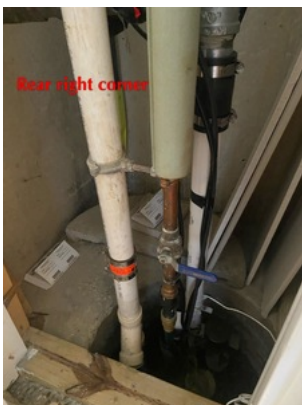
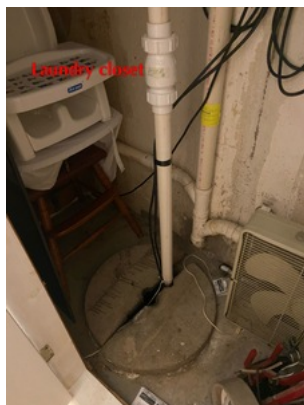
Both sump pumps (one by laundry, one at rear right corner) operate as expected.
